# PL 84-99 Rehabilitation Program

CORPS/RECLAMATION BOARD/DWR  
MEETING WITH LOCAL MAINTAINING  
AGENCIES

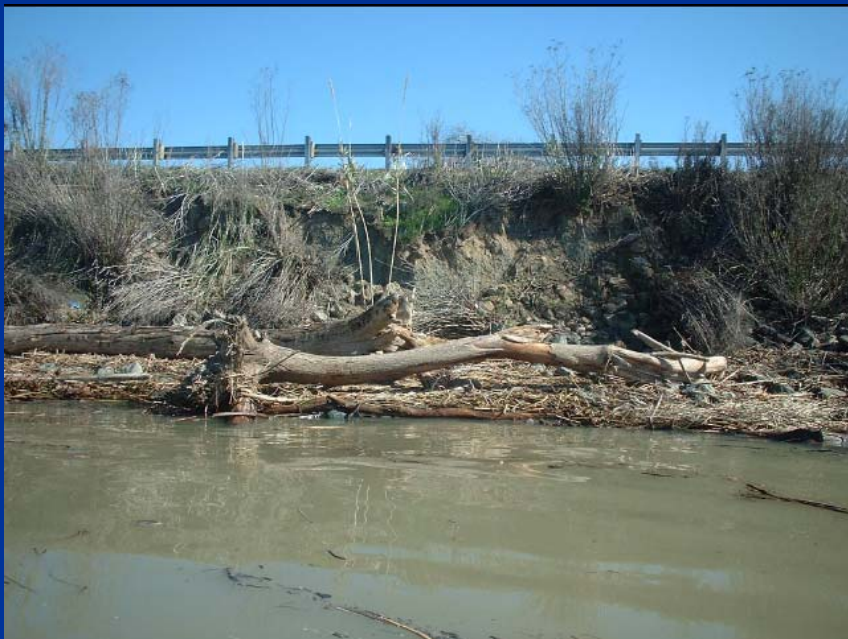
# Criteria – Order 1 & 2

**Order 1:** The damages are severe enough that they may lead to loss of the levee before the next flood season. These levees are protecting urban areas where lives are at risk or where there may be a large economic impact.

**Order 2:** The damages are severe enough that they may lead to loss of the levee before the next flood season. These levees are protecting undeveloped areas.

- Vertical cut in the levee slopes higher than 10 feet,
- Vertical cut close to the levee crown with high traffic on the paved road on the levee crown (i.e. Hwy 160)
- Slides in the waterside or landside levee slope close to the levee crown that may lead to progressive failure of the levee,
- Sand boils removing material from the levee foundation that may lead to collapse of the levee due to piping.

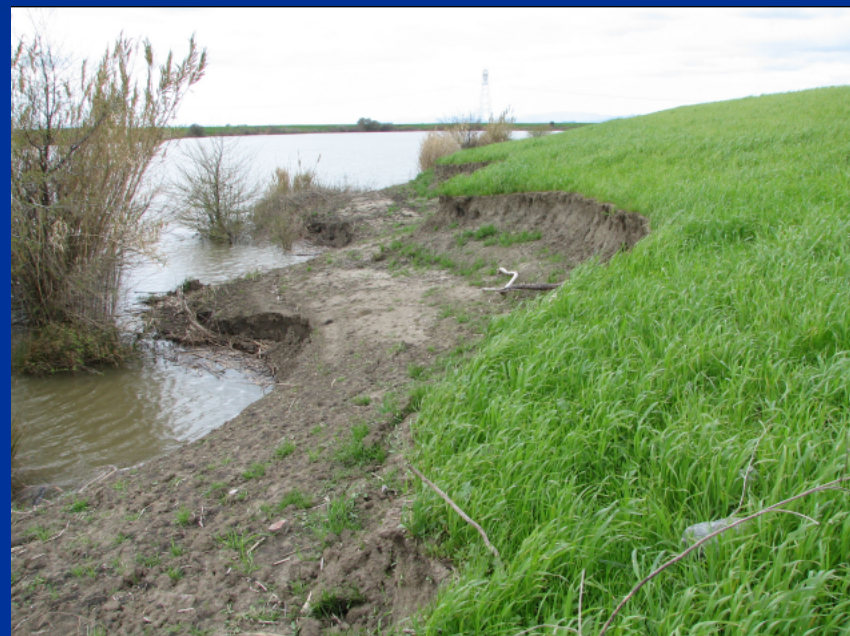
# Criteria - Order 3

**Order 3:** Severe damages that may extend into the next flood season but are less likely to lead to levee breaches.

- Vertical cut of the levee toe at least 5 feet but less than 10 feet
- Loss of riprap and erosion 4 to 8 feet into the levee slope
- Small slides of the levee toe
- Wave wash 3-5 feet and erosion of the levee toe.

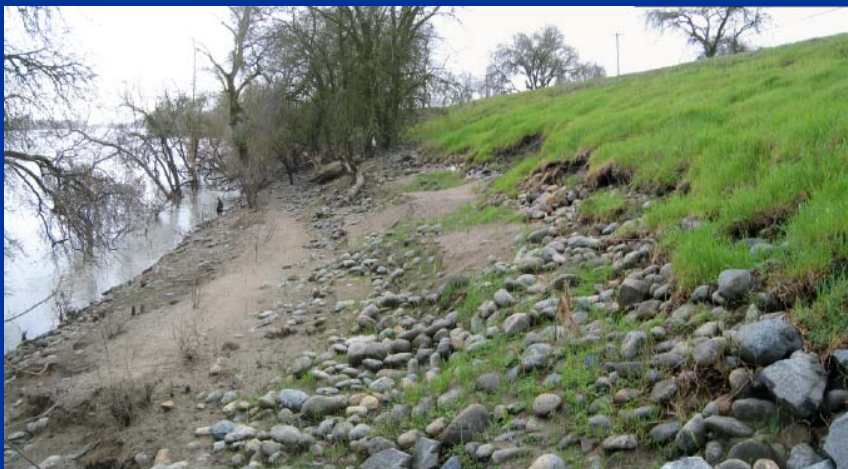
# Criteria - Order 4

**Order 4:** Minor damage that may be exacerbated during the next flood but will not lead to the loss of the levee embankment:

- Wave wash less than 3 feet into the levee slope
- Erosion less than 3 feet of the levee toe
- Seepage with clear water not carrying material from the levee foundation or levee embankment
- Damages to the crushed rock of the levee patrol road

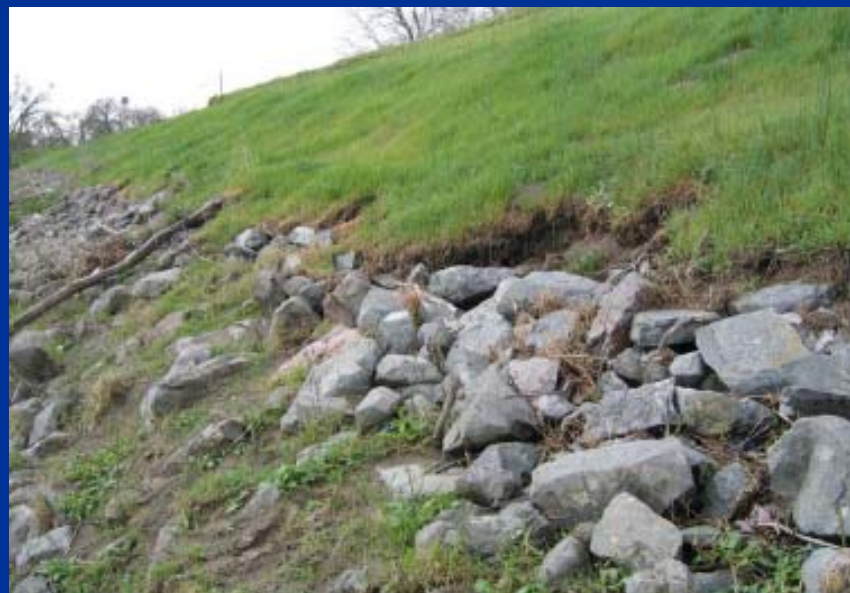
# Criteria - Order 5

**Order 5:** All other minor damages that will not affect the functionality of the levee and are not critical for the levee embankment.
